Manhole Inspection Summary

Manhole # S09UU_010MH

Insp Date: **2/19/09 11:40 AM**

Location Address: **3200 HILTON ST**

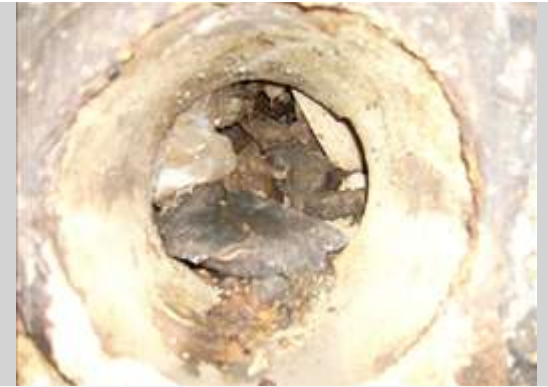
9 O'Clock Inflow

12 in. Circular Gravity Sewer

Pipe In @ 9 O'Clock

Pipe Material: **Concrete** ☐ Pipe Lined

Invert Depth: **11.35** (ft.) Flow Characteristics: **None**

Deposits: ☒ None ☐ Mud ☐ Sludge ☐ Debris ☐ Grease

Infiltration: **None** Pipe Seal Cond: **Sound**

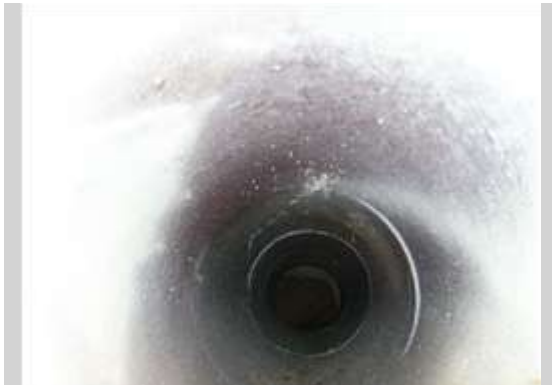
11 O'Clock Outflow

18 in. Circular Gravity Sewer

Pipe Out @ 11 O'Clock

Pipe Material: **Concrete** ☐ Pipe Lined

Infiltration: **None** Pipe Seal Cond: **Sound**
